Current measurements of upward leaders from buildings

Marcelo M.F. Saba, Amanda R. de Paiva, Kleber P. Naccarato, Fernando V. C. Siqueira, Fernanda S. Sabbas
CST/DAE/INPE – National Institute for Space Research
São José dos Campos, Brazil

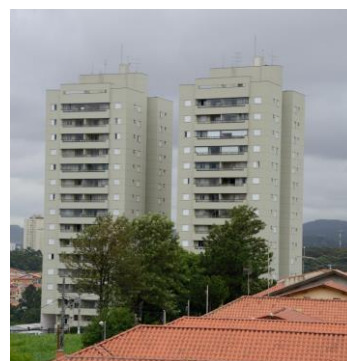
Fig. 1. a) Identical 14-story apartment buildings (P1 on the left and P2 on the right); b) Location of the cameras (210 m from P1 and P2).

In order to observe lightning attachment to common buildings, two high-speed video cameras, a still camera and two standard video cameras were positioned at a distance of 210 m from a pair of identical 14-story apartment buildings, named P1 and P2 (see Fig. 1), located in São Paulo City (23.483°S, 46.728°W), Brazil. Their steel reinforced concrete structures are used as natural LPS. Each building has a vertical lightning rod, and their tips are at a height of 52 m respective to ground floor.

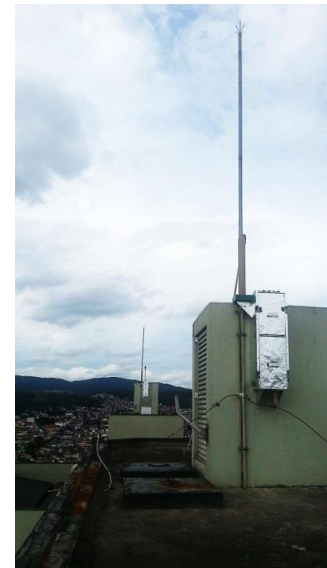
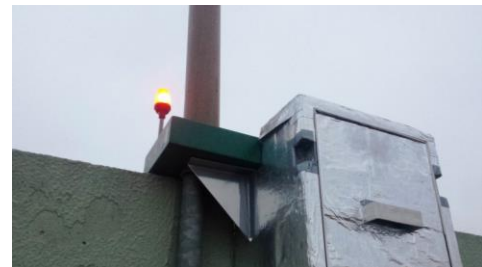
Fig. 2. Current sensors installed on the lightning rods of buildings P1 and P2 (upper picture) and detail of the installation (lower picture).

One Pearson current sensor model 301-X was installed on the lightning rod of each building (see Figure 2). This current sensor is capable of recoding current up to 50,000 A with an useable rise time of 200 nanoseconds, a low frequency 3 dB cut-off of 5 Hz (approximate) and a high frequency 3 dB cut-off of 2 MHz (approximate). The output of the sensor is split in two channels (20 dB and 50 dB attenuation over 50 Ω), and sent to a data acquisition system through a pair of fiber optic links. Before installation, both sensors were tested and calibrated in the high voltage facility at IEE/USP.
