# Lightning attachment process to common buildings

INPE – National Institute for Space Research  
São José dos Campos, Brazil

**Abstract**— In this paper we analyze upward connecting leaders induced by some downward negative lightning flashes that struck an ordinary residential building located in São Paulo City, Brazil. Most of what is known about the current of downward flashes comes from information gathered on towers. There are no observational data of lightning attachment to common structures or buildings (under 60 m) that are present in almost every city. For the first time, the attachment process was analyzed by a high-speed camera running at 10,000 images per second. The striking distance observed was larger for return strokes with higher peak currents. The ratios of speeds of the downward leader and the upward connecting leader varied from 1 to 9. The final jump discharge initiated from the positive upward connecting leader

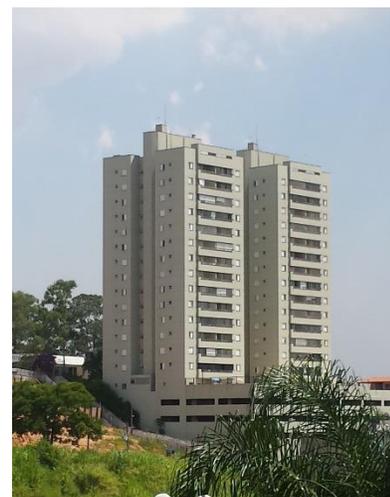
Fig. 1. Identical buildings (P2 on the left, P1 on the right), both have the same LPS installed.

The present study presents results from measurements of cloud-to-ground lightning flashes that struck a pair of common identical 14-story apartment buildings (Figure 1) in São Paulo City (southeastern Brazil). The tip of their lightning rods is at a height of 52 m. Their steel reinforced concrete structures are used as natural LPS. The flash density  $N_g$  for the region is about 11 flashes/km<sup>2</sup>.year [ELAT, 2015].

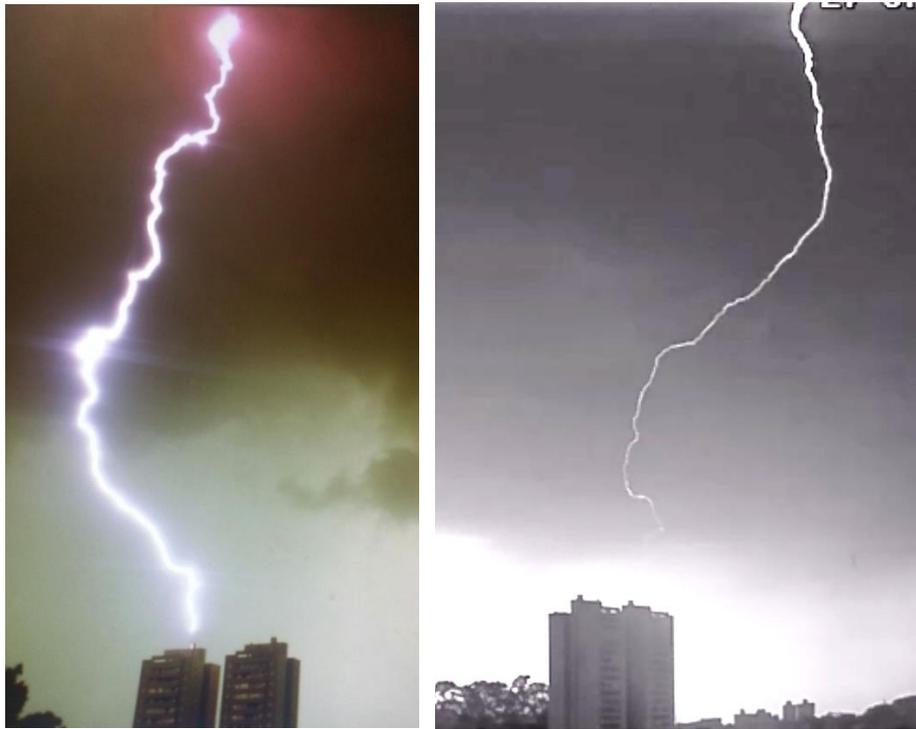
Fig. 3. Images of the same lightning strike from different angles.

In preparation to a study of lightning attachment, several cameras were placed around the buildings. Images from different angles are available (Figure 3). A high-speed digital video camera (Vision Research's Phantom v711) with time-resolution and exposure times of 50 and 100 microseconds
